# Exhibit F

## Degradation of polypropylene in vivo: A microscopic analysis of meshes explanted from patients

### Vladimir V. lakovlev, 1 Scott A. Guelcher, 2 Robert Bendavid3

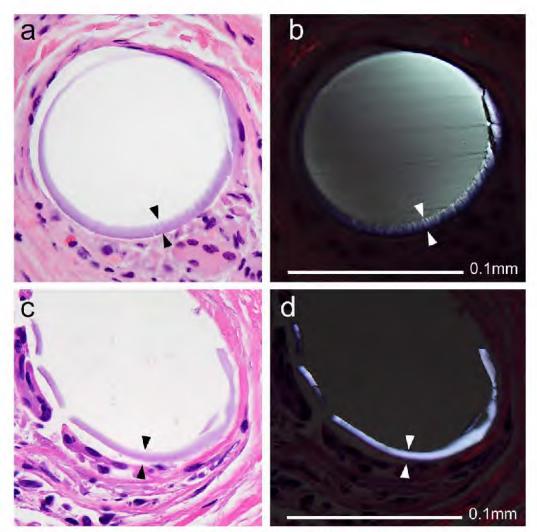
FIGURE 2. Histological sections, H&E stain, ×100 objective with oil immersion. The same cross section of a clear mesh fiber in regular (a) and polarized (b) light. The fiber has a layer of staining degraded polypropylene at the surface (between arrowheads). This layer has refractile properties of polypropylene in polarized light (b). In some areas the non-degraded core of the fibers detaches during histological processing while segments of the degraded layer stay attached to the tissue. Separated degradation layer in regular (c) and polarized (d) light. At sites like this, intensity of light passing through the degraded layer cannot be attributed to light scatter from the core. Note that tissue components including collagen have a much weaker birefringence than polypropylene (b and d). [Color figure can be viewed in the online issue, which is available at wileyonlinelibrary.com.]

polypropylene. In polarized light, both the central core of the fibers and the outer layer showed similar refractile properties [Figure 2(b)]. The light intensity was uniform within the core while the outer layer had gradual reduction of the refractile ability toward the surface. Birefringence of the outer layer was also observed in the segments of the "bark" separated from the core [Figure 2(c,d)]. At these sites, the light brightness in the "bark" layer was due to its internal properties and could not be attributed to the scatter of light from the core. The adjacent tissue components containing collagen also showed birefringence, however of a much lower intensity. The tissue components also had a different structure and coloration

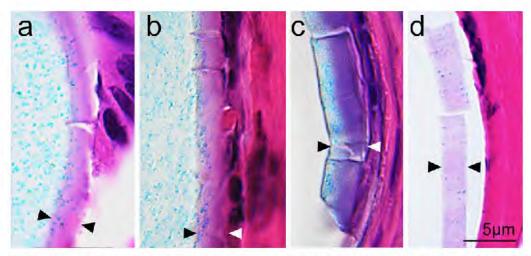
FIGURE 3. Degradation "bark" of the blue fibers manufactured with inclusion of blue dye granules, H&E stain, ×100 objective with oil immersion: (a) and (b) non-degraded core (left half of the images) and the degraded layer (between arrowheads). Note that the blue granules are retained in the layer of degraded polypropylene. Within the degraded "bark," the granules degrade and loose color toward the surface. In (c) and (d) the non-degraded core detached from the slides similarly to Figure 2(c,d). At these sites, presence of the granules in the separated "bark" cannot be attributed to an overlap with the core. [Color figure can be viewed in the online issue, which is available at wileyonlinelibrary. com.]

into the material during its manufacture (Figure 3). The granules were seen in the non-degraded core of the fibers as well as to a variable degree in the outer degradation layer. In the latter, they were detected within the "bark" remaining on the core [Figure 3(a,b)] as well as in the segments of the "bark" separated from the core [Figure 3(c,d)]. The granules were mainly seen in the deeper layers of the "bark" and were not as frequent closer to the surface, which suggests that they also undergo degradation and lose color. The finding was a direct confirmation that the "bark" originated from the same material as the core of the fibers.

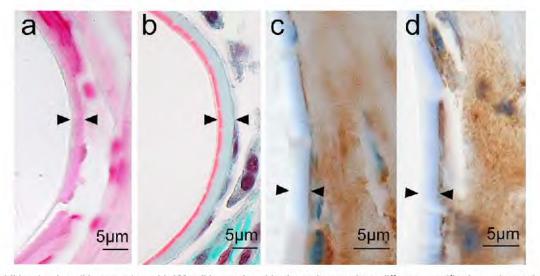
The brittleness, staining and birefringence characteristics of the "bark" were similar to those of calcium salts which are commonly deposited in degenerating tissues. Von Kossa stain was used for a sample set of 10 specimens to rule out presence of calcium salts in the outer "bark." No calcium salts were detected in the brittle outer layer of the 10 specimens tested [Figure 4(a)].

FIGURE 4. Additional stains, all images taken with 100x oil immersion objective and cropped to a different magnification, polypropylene degradation layer is pointed between arrowheads: (a) Von Kossa stain is negative for calcium in the brittle "bark" (would stain calcium black), (b) trichrome stain shows that the deeper parts of the "bark" have smaller staining porosity (red) than those close to the surface (green) which correlates with TEM findings [Figure 6(b)], (c) immunohistochemical stain for immunoglobulin G (IgG, stained brown). IgG is present in almost all human tissues and fluids. It is deposited on the surface of degraded polypropylene but is not mixed within it. (d) Immunostain for the oxidizing enzyme of inflammatory cells myeloperoxidase (stains brown). [Color figure can be viewed in the online issue, which is available at wileyonlinelibrary.com.]

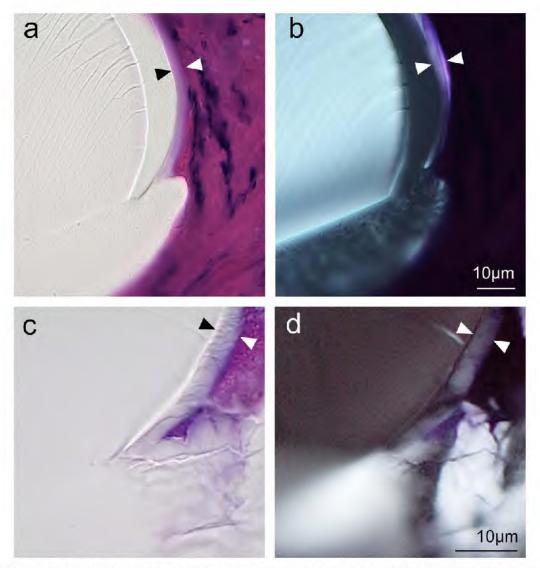
FIGURE 5. Melting of both non-degraded and degraded polypropylene caused by the surgical cautery, H&E, ×100 oil immersion: (a) and (b) the same site of fiber melting in regular and polarized light, (c) and (d) another site showing melding point. While molten the non-degraded core and the degradation "bark" formed a common pool of material. [Color figure can be viewed in the online issue, which is available at wileyonlinelibrary.com.]

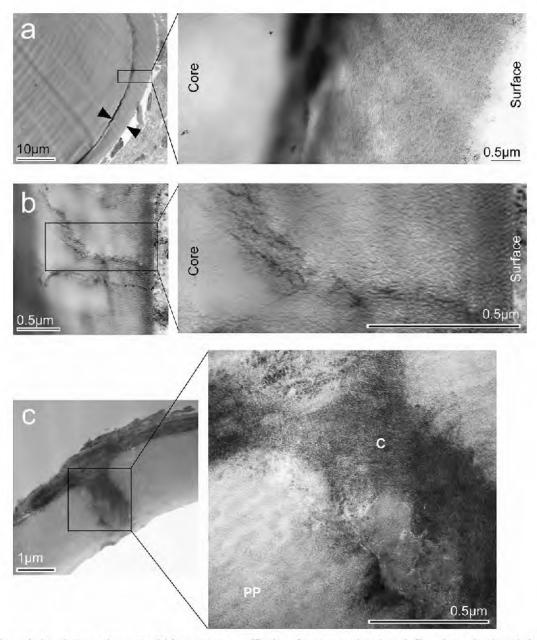
We used TEM to study the ultrastructural organisation of the degraded layer in cross sections. The mesh fibers showed an outer "bark" similar to that seen by light microscopy [Figure 6(a)]. There were no fibrillary (collagen, amyloid etc.) or other structures of connective tissue matrix within the "bark". Material composition of the outer layer and the core showed similar electron density; however, at high magnification the outer "bark" was noticeably more granular, especially toward the surface [Figure 6(a), insert].

The "bark" material had a lattice of fine branching cracks (nanocracks). This network of nanocracks was sparse closer to the core and expanded toward the surface [Figure 6(b)]. As seen in Figure 6(b) in addition to the nanocracks there were also occasional larger cracks occurring at random. These larger cracks seen by TEM corresponded to the cracks seen by light microscopy either on the surface (Figure 1) or in cross sections (Figure 2).

The "bark" either had a gradual transition into the core [Figure 6(b)] or showed a zone of circumferential fissuring partially separating it from the core [Figure 6(a)]. The mechanisms of "bark" separation from the core and formation of the larger cracks are likely linked since the cracks tended to turn at the interface between the "bark" and the core [Figure 6(b)]. The forces which produced the transverse (radial) cracks also acted as shear forces between the "bark" and the core.

An important finding was the detection of inflammatory cells partially migrated into and trapped within the fissures as shown in Figure 6(c). The shape of widened crevices and the depth of penetration indicated an active *in vivo* cellular migration. This phenomenon was observed at two separate sites.

FIGURE 6. Transmission electron microscopy. (a) Low power magnification of a cross-sectioned mesh fiber shows the degradation layer similarly to light microscopy, the insert shows an image composed of three high power fields to reconstruct the transition between the non-degraded core and the degradation "bark." Note the fine nanocracks/nanopores in the degraded material. (b) Outer part of the fiber with gradual transition between the non-degraded core and the degraded polypropylene at the surface. The lattice of nanocracks expands toward the surface (left to right). There are also two larger cracks which start perpendicular to the surface but then turn at the interface between the core and the degraded layer. (c) A part of inflammatory cell (labeled C in insert) is trapped in a fissure within the degraded polypropylene (PP). Higher magnification (insert) shows cellular membrane at the cell-polypropylene interface (left wall of the fissure) and cellular organelles in the cell (chains of rounded structures, likely ribosomes).

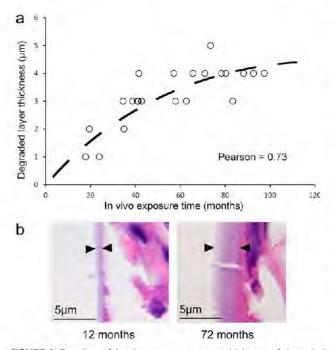
Out of all the specimens, 23 samples of explanted midure-thral slings formed the largest group of meshes from the same manufacturer, of identical mesh type and with reliable records of implantation and excision dates. The range of *in vivo* interval (between implantation to excision) in the group was 18–97 months (mean 53). There was a good correlation (Pearson = 0.73) between the thickness of the degradation layer and the duration of *in vivo* exposure indicating that the thickness of degraded material grows while the mesh is in the body [Figure 8(a,b)]. There was a trend for a more rapid initial growth with gradual plateau subsequently.

**FIGURE 8.** Duration of *in vivo* exposure versus thickness of degraded layer in a group of explants of the same manufacturer and the same mesh design. (a) Thickness of the degradation "bark" increased over the years *in vivo* (Pearson correlation = 0.73). Note the trend of plateauing after 5–6 years. There was no correlation of the thickness with the duration of specimen storage in formalin (not shown, Pearson = -0.06). (b) Comparison of the "bark" in meshes explanted after 12 and 72 months in the body, H&E,  $\times$ 100 objective with oil immersion, images cropped to the same magnification factor. [Color figure can be viewed in the online issue, which is available at wileyonlinelibrary.com.]
